# **Natural History, Hydrology and Water Quality of Enchanted Lake – Kaelelepu Pond**

Robert E. Bourke  
437 Keolu Drive  
Kailua, Hawaii

October, 2016

## ABSTRACT

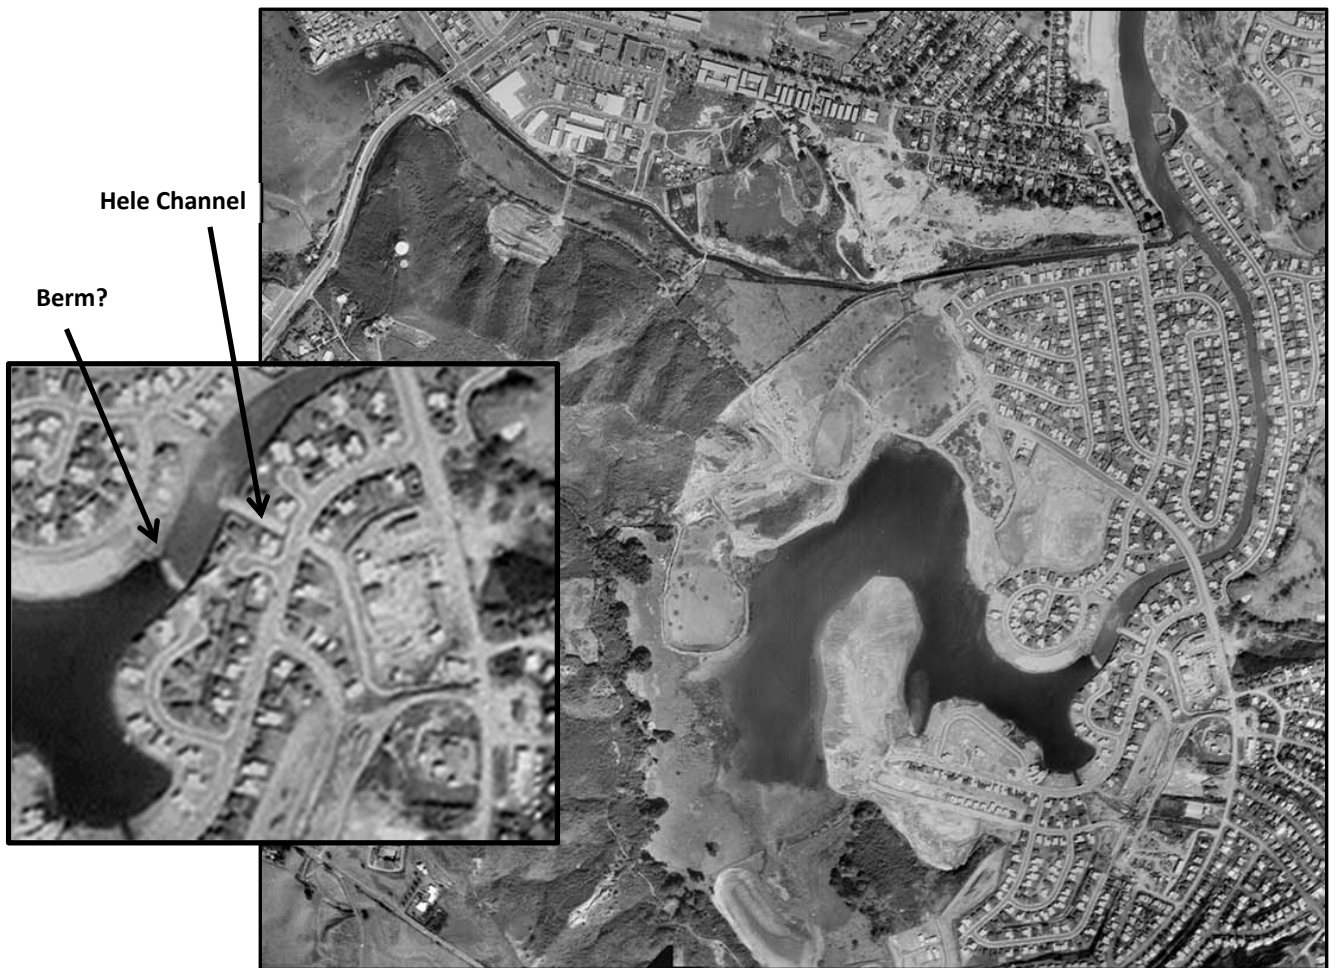
Figure 6. 1963 aerial photo of Enchanted Lake under construction. Note lack of Kawainui levee and presence of berm across stream exit from pond with heavy silt load entering from Hele Channel inlet (enlarged inset) where the stream channel is still very shallow. USGS: EKM-2CC-246, 1-14-63.

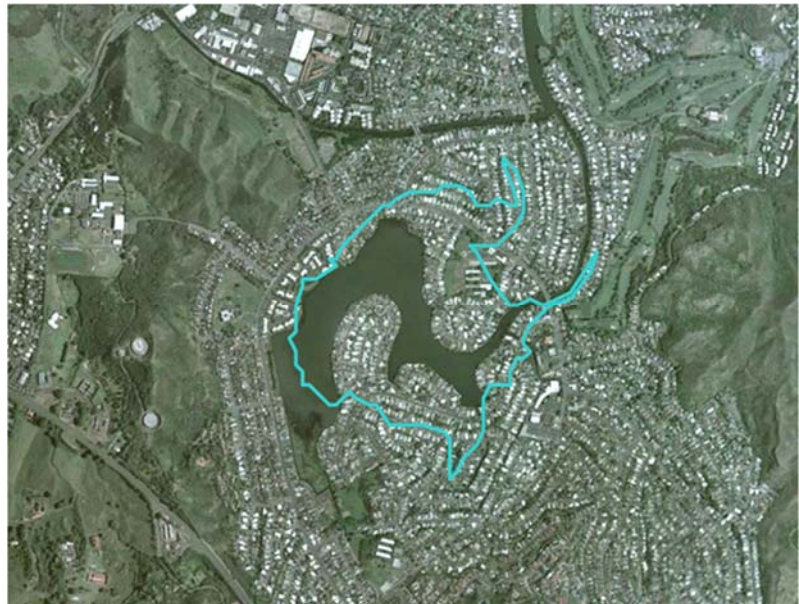
**Figure 7 Outline of the 1926 Kaelepulu Pond superimposed over present day Enchanted Lake.**

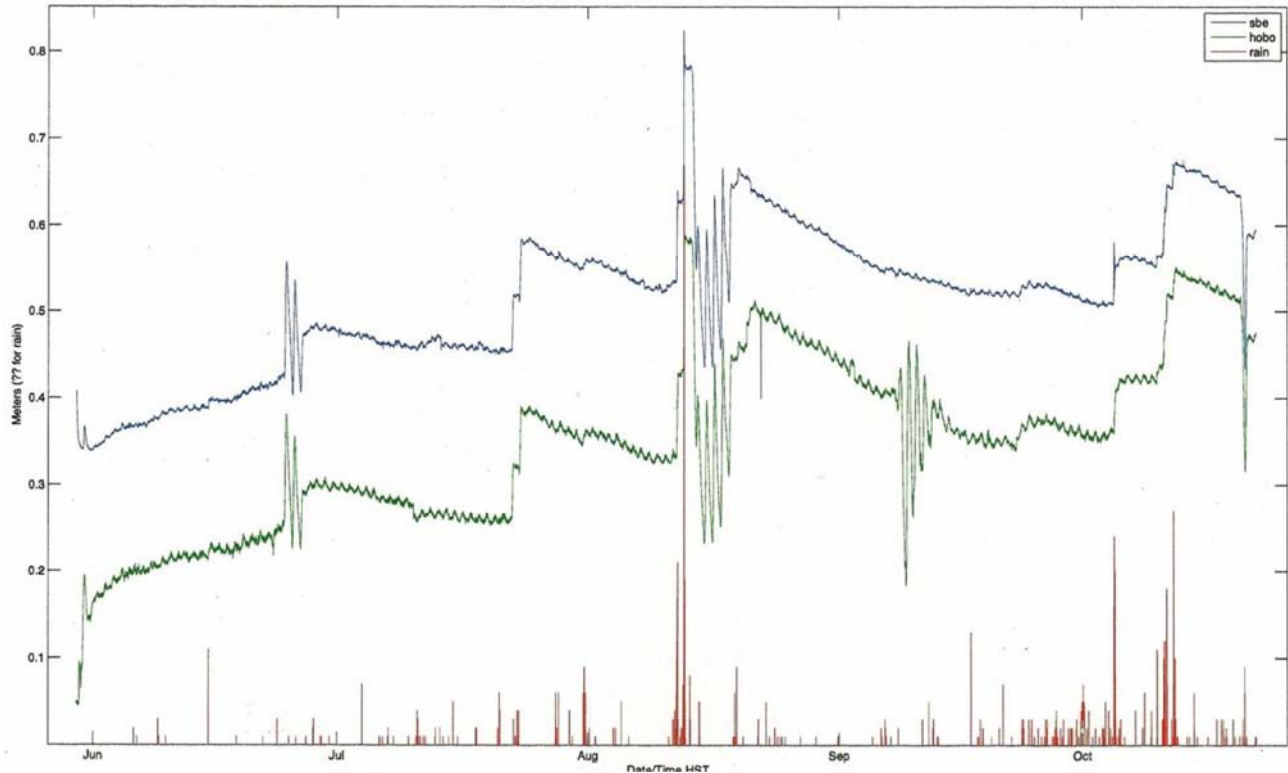
**Figure 16 Typical pond water surface elevation patterns associated with rainfall, evaporation, and stream mouth berm opening events as recorded 5/30/09 through 10/22/09. Evaporation rate in the absence of rainfall is about ¼-inch per day (From: Babcock & Tamura, 2010).**

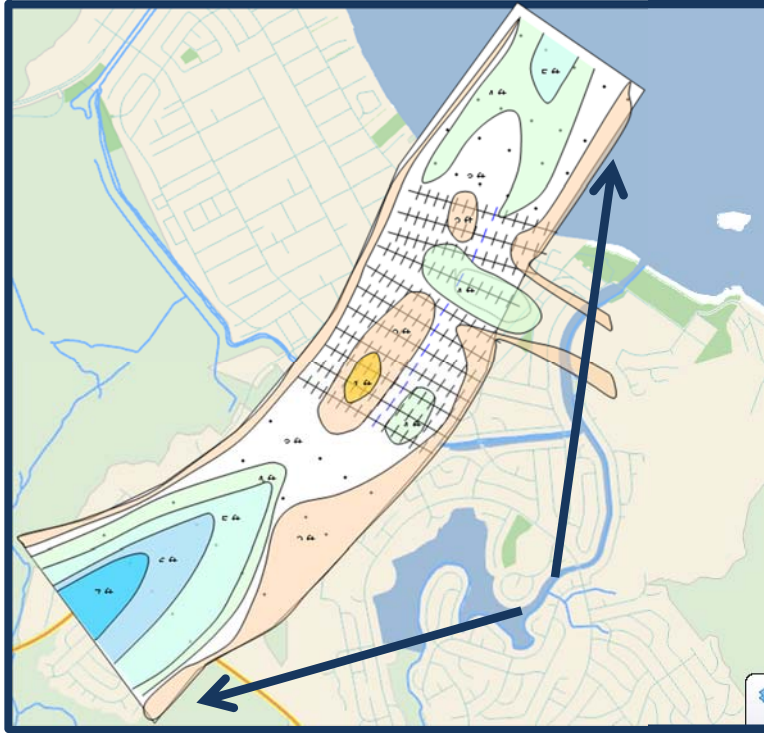
Figure 17. Top: The mouth of Kaelepulu Stream as it exits the pond is shoaled to within a foot of the surface and dramatically impacts circulation between the stream and the pond. Bottom map graphically depicts the estimated relative volume of water in each section of the estuary as represented by cubes with a base as shown

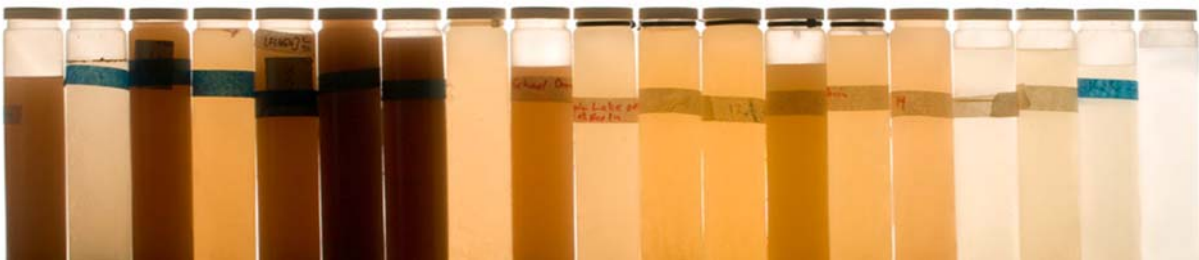
**Figure 19 Water quality samples from pond inlets obtained during a single runoff event (3/19/06) distinguish between drainages that have active construction grading projects and those that do not.**

The most obvious source of pollutants to the system is sediment in runoff from construction sites with inadequate erosion and runoff controls. The samples depicted in Figure 19 were taken during a single storm event from inlets all around the pond. The inlets influenced by construction sites are obvious. Data from analyses of the above samples is presented in Appendix B.

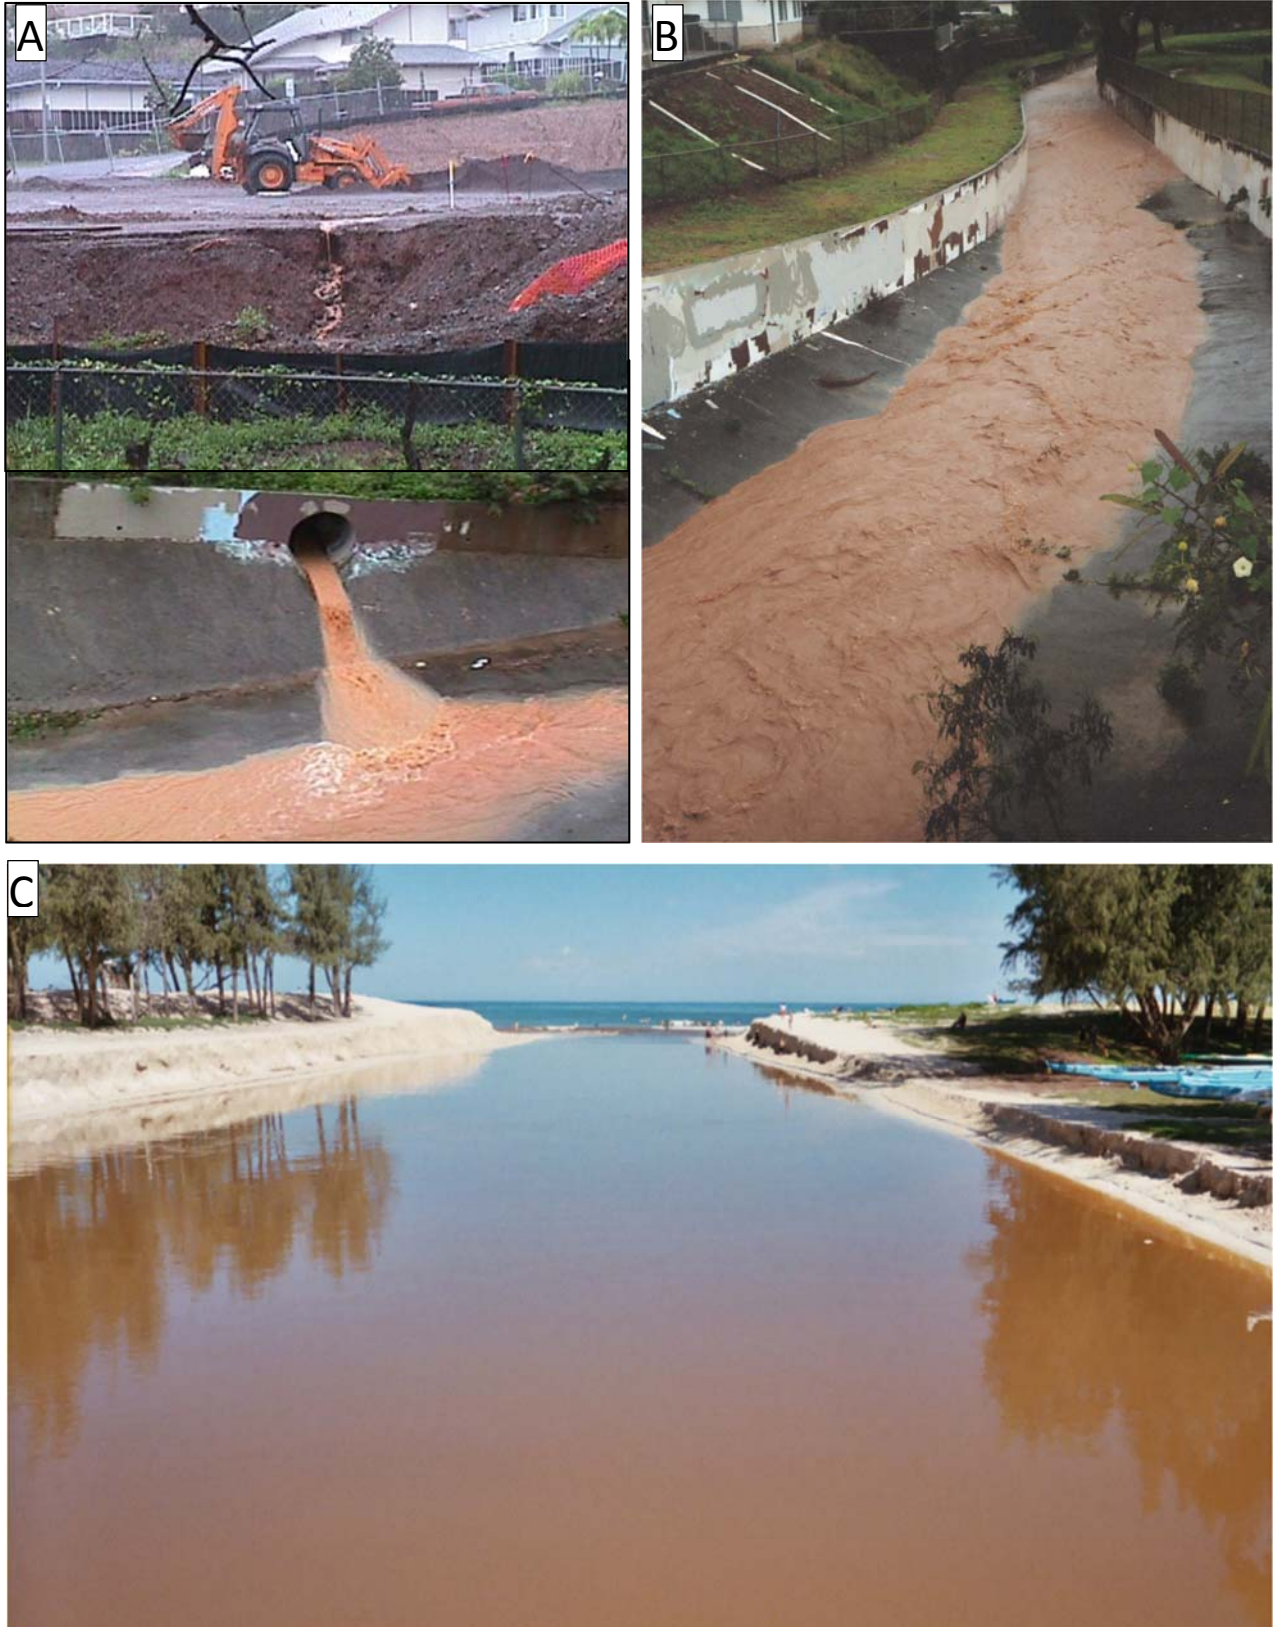
**Figure 20** Construction activities (A) have the greatest impact upon delivery of sediment and nutrient turbidity to the pond (B) and into the ocean (C) when the stream mouth is open.

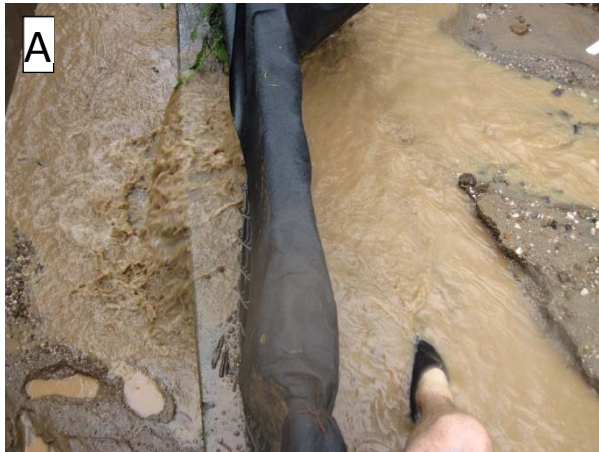
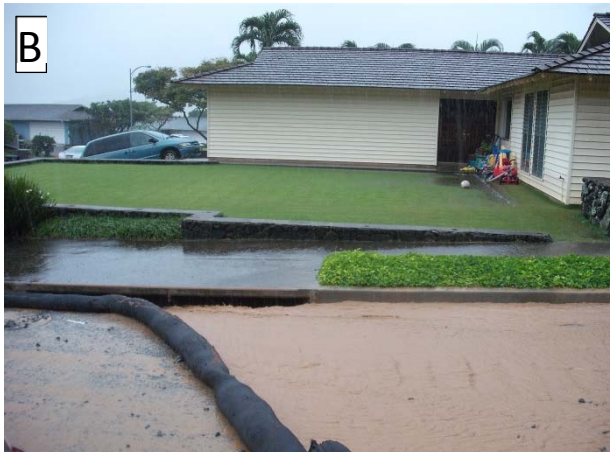
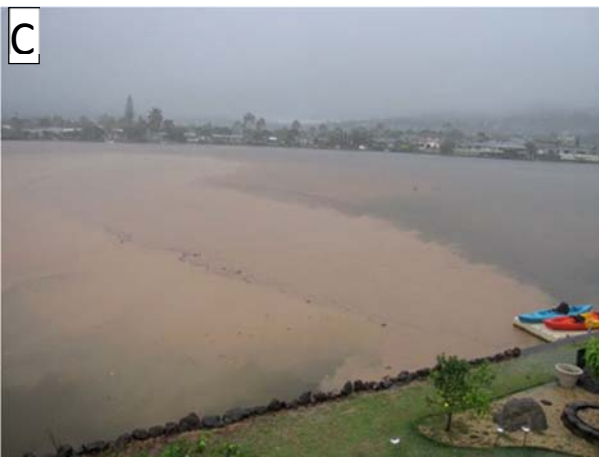
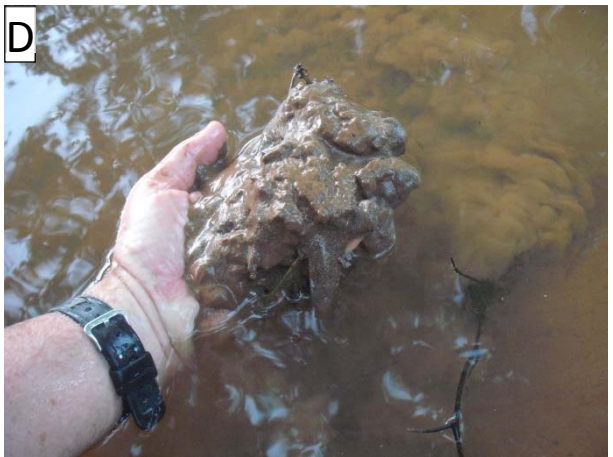
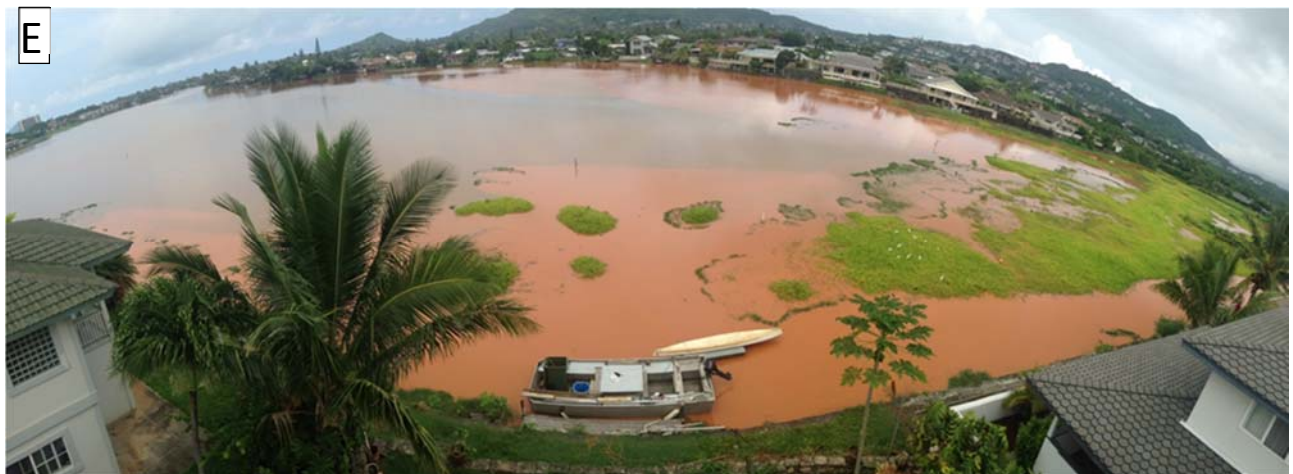
**Figure 21** Poorly implemented BMPs at construction sites (A) or intentional by-passing of required BMPs (B) result in significant plumes of turbid water entering the pond (C) and deposition of fine mud throughout the estuary (D). The high iron content of the soil colors the pond bright orange for several days following major rainfall events when land is being graded in the watershed.

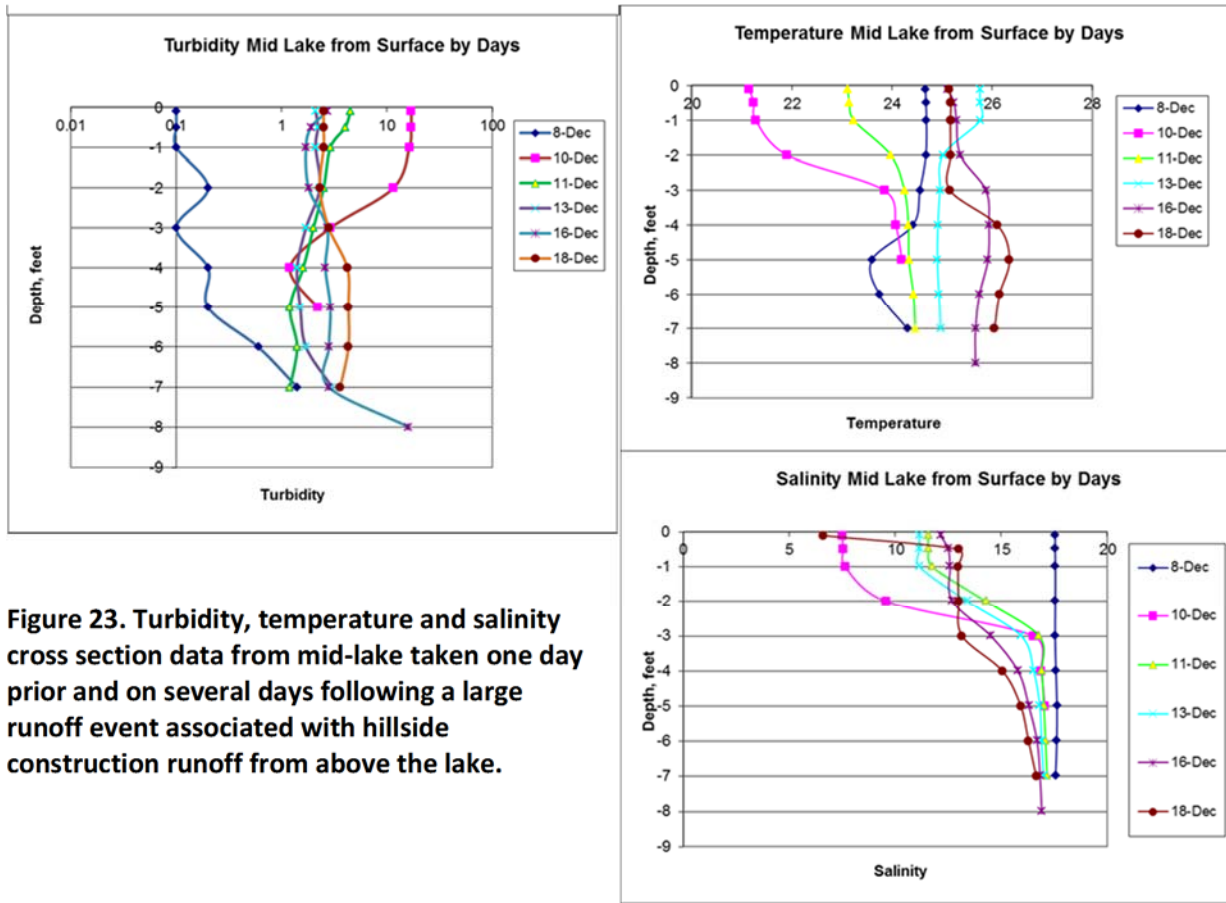
**Figure 23. Turbidity, temperature and salinity cross section data from mid-lake taken one day prior and on several days following a large runoff event associated with hillside construction runoff from above the lake.**

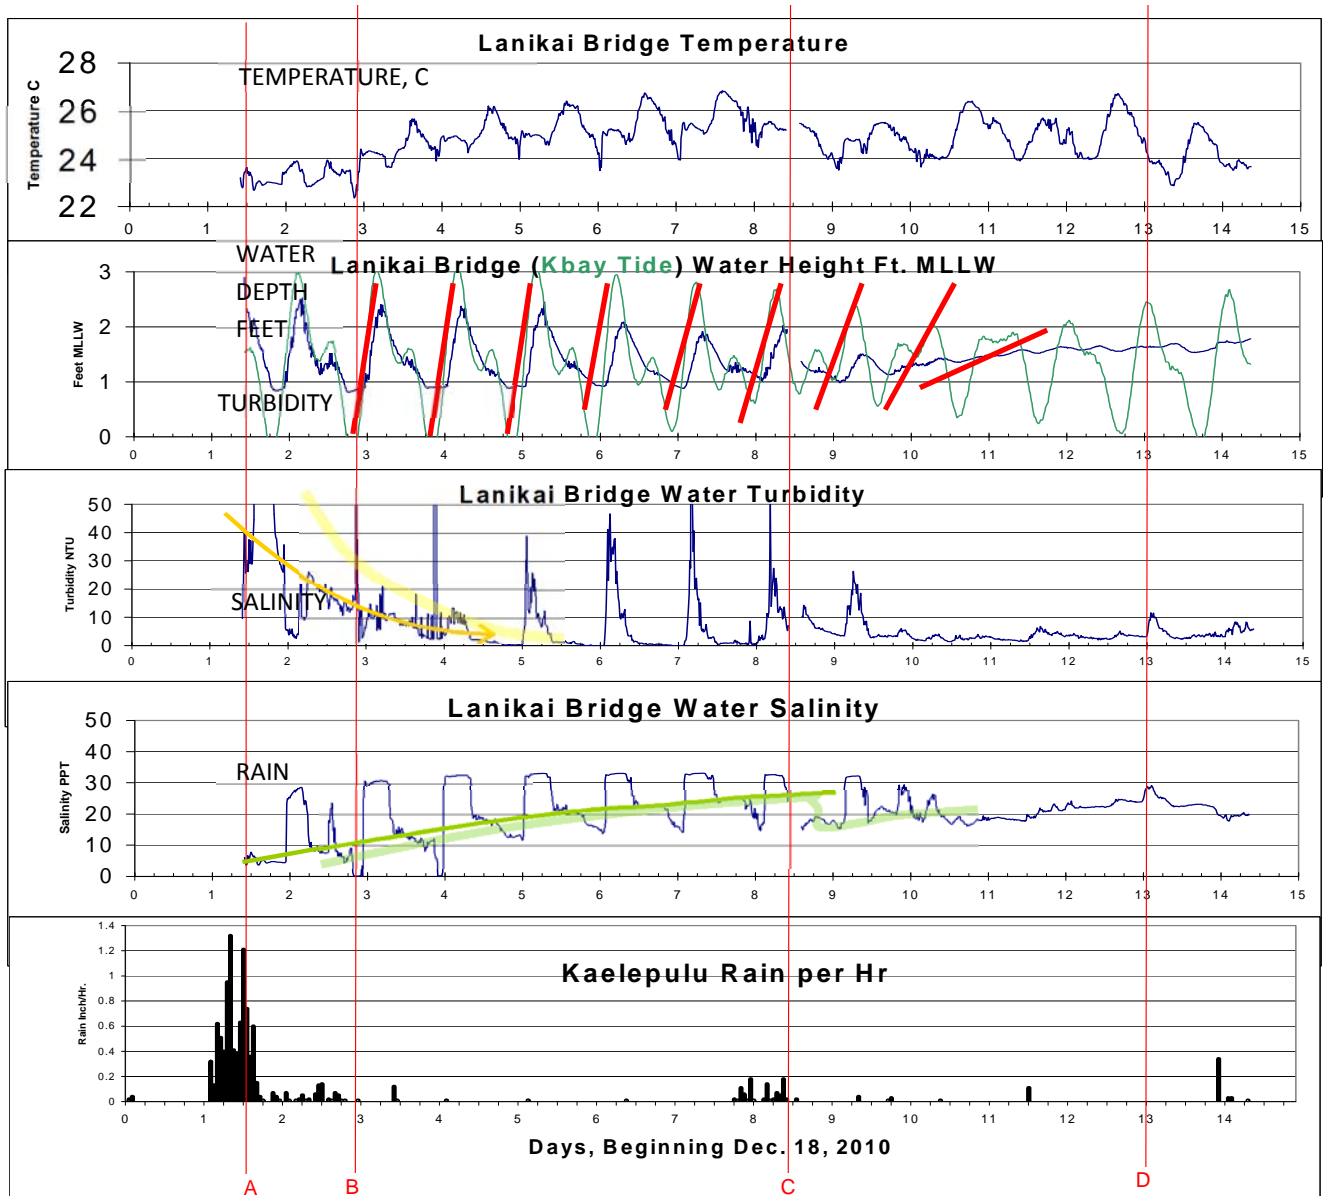
Figure 24. Dynamics of water quality during stream opening following December 18, 2010, 9-inch rainfall event as measured at Lanikai Bridge using a YSI water quality sonde.

During one very large rainfall event (9-inches on 12/19/10) the water surface of the 142 acre estuary rose from 1.73 feet to 3.4 feet LMLLW before the sand berm was over-topped and the water began to flow to the ocean (Figure 24). A YSI water quality data sonde on the Lanikai Bridge at the mouth of Kaelepulu Stream recorded a turbidity of about 80 NTU as the estuary fell to an elevation of 0.9 feet (Figure 24Error! Reference source not found.). 2.5 feet of water drop across the 142 acre estuary represents about  $5.59 \times 10^9$  liters of water. If a turbidity of 80 ntu is equal to a TSS of 40 mg/l (Figure 22) then a first order calculation would suggest that about 22 metric tons of sediment was carried to Kailua Bay during the first period of stream outflow following this storm.

In the runoff event displayed in Figure 24 we estimate that 22 tons of sediment were washed into Kailua Bay, but we know from sediment settlement calculations (Figure 22) that it is likely that upwards of 90% of the sediment (200 tons) remained in the pond and stream channels. When construction sites have large quantities of land open and inadequately protected from erosion, the quantity of material that is transported to the lake and from there to Kailua Beach over the period of several storms can be highly significant.

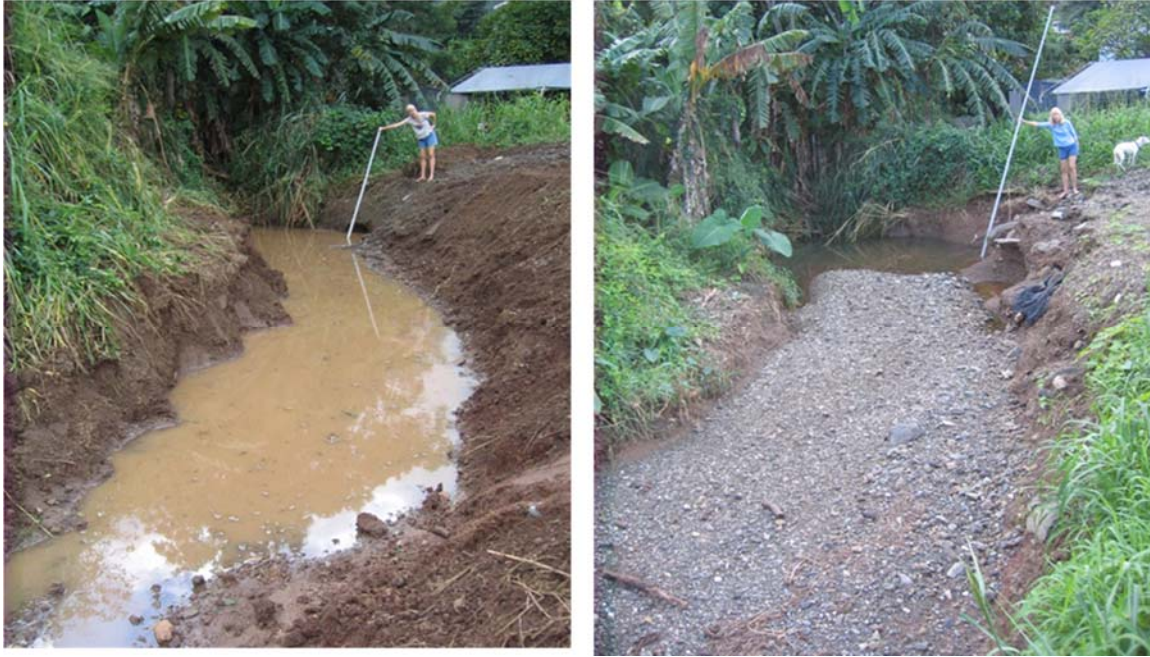
**Figure 25. Before (left) and after(right) sediment from a City storm drain filled this swale during a single storm. The staff is a 16-foot survey rod.**

In the spring of 2004, a lot owner was conducting filling and grading of a steep parcel. The main drain from the parcel empties at the back of the "wetland" property owned by the de Vries family, who had been in the process of excavating the drainage easement between the end of the drain pipe and the Kaelepulu Stream. The two photos (Figure 25) show the result of a single 4-inch rainfall event that transported and deposited the estimated (8x30x120 ft) 1,000 cubic yards of sand gravel and rock into the excavation. Note that all of the fines, which typically represent at least half of the total quantity, were all washed into the stream and wetland.

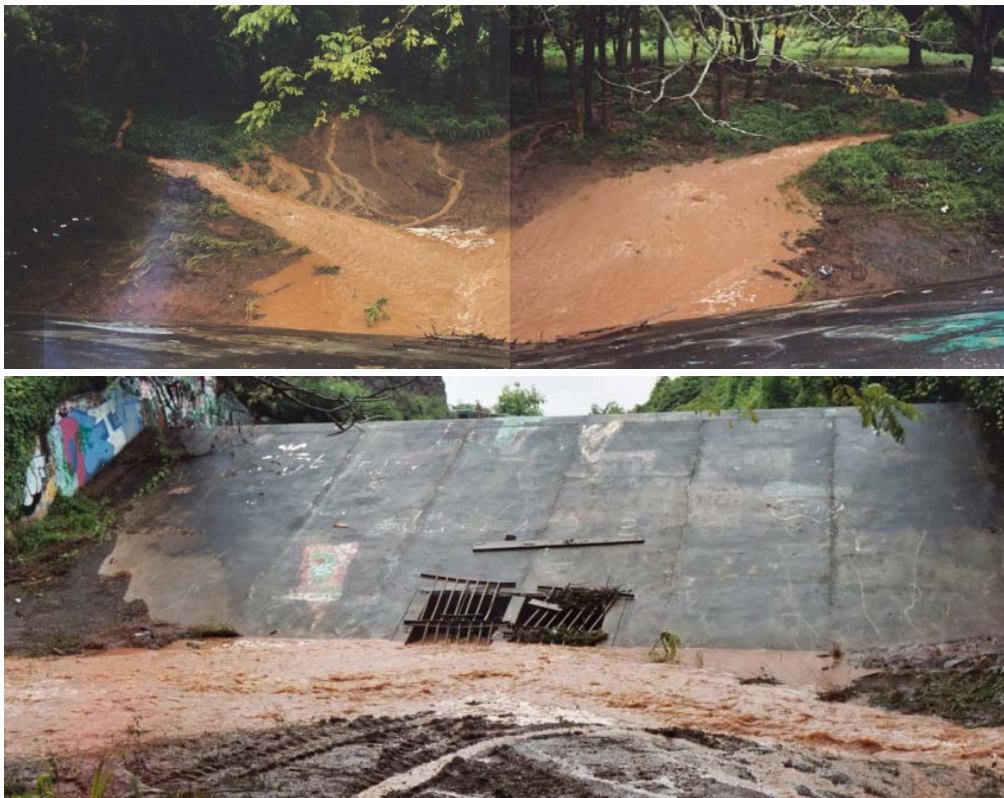
**Figure 26. Top: Looking down the inside dam face as muddy water pours through the two erosional channels cut through the internal raised berm. Bottom: Inside the basin looking at the back of the dam face with the muddy water flowing into the two flow control structures beneath the dam.**

The Keopa flood control basin (TMK 42004048) was constructed (1971-1972?) as part of the Kailua Bluffs development in the early 1970s and the dam deeded to the City for maintenance. The structure intercepts most of the runoff from the upper portion of the watershed and conveys it into Kaelepulu Pond through a concrete lined Kaelepulu Stream (Figure 20, upper right). In a very large (100 year 6 hour) storm the basin may receive runoff as high as 2,322 cfs (almost half of the total flow to Kaelepulu Pond) but limits the outflow to only 397 cfs (ParEn, 1993). In even larger storms when inflow may be as high as 3,665 cfs, the structure will overflow, but still limit the discharge to “only” 2,560 cfs. Although the dam is owned and maintained by the City, the actual basin is privately owned. Within the basin and about 100-feet back from the inner dam- face is a dirt mound (access easement) that is raised two or three feet above the basin floor and running across the width of the basin. This mound serves as an internal retention basin and likely was very effective as a silting basin to capture sediments during runoff events. Unfortunately, a lack of maintenance (this is within the privately owned section of the property) has allowed the formation of two erosional gullies through the mound which negates the effectiveness of this structure to capture sediment. This portion of the basin is also listed as a wetland on the City’s GIS map site, which would greatly complicate the permit process to make repairs to this berm. With minimal alterations to the internal configuration of the Keopa Basin, this structure could be greatly improved to act as an effective sedimentation basin for the watershed.

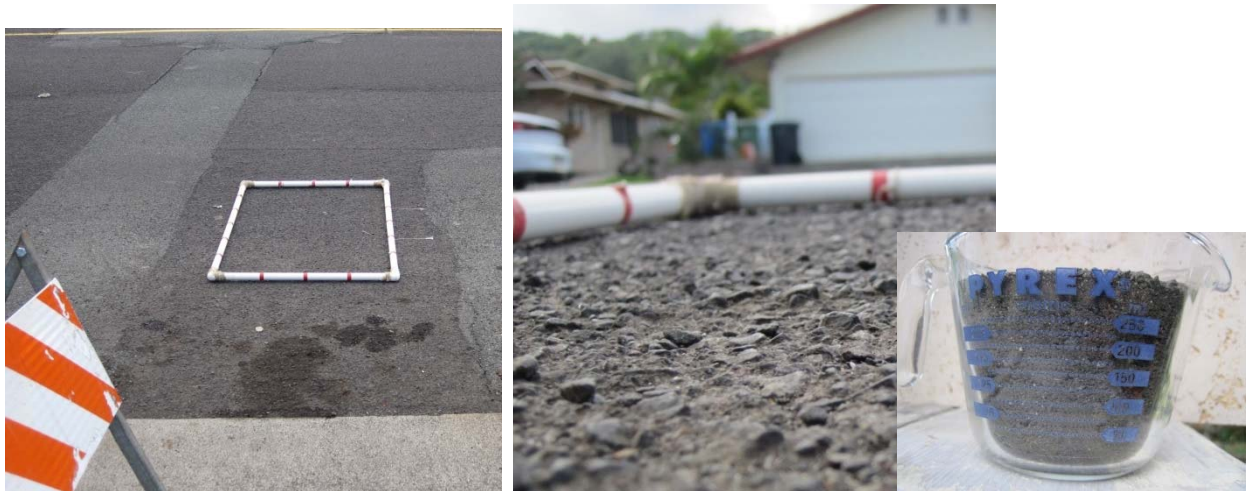
Figure 27 Testing for quantity and quality of material eroded from City road surfaces.

Many of the inlets into the pond are fronted by a shallow area of built up sediment. When digging in these areas one often comes across deposits of fine gravel similar to the type used in asphalt. When Keolu Drive was re-surfaced in 2010, measurements of the eroded street surface were made prior to re-surfacing. One square meter of road surface was found to have eroded at least 3 liters of material of which 325 cc's of sand and gravel still remained. Given that there are 5.75 miles of City roadways in the watershed, the total area of all roads (assumed average width of 53 ft) is about 150,000 square meters and the total eroded material is about 450 cubic meters of material. This is equal to about 588 cubic yards, or 60 ten-yard dump trucks. Assuming this erosion took place over a period of 15 years yields an annual erosion rate from City Roads of about 39 yd<sup>3</sup>/year.

Road surfaces are often considered to be sources of heavy metals like Chromium, Lead, and Cadmium due primarily from automobile engine and brake wear. Samples of gravel from the lake below a storm drain after a big storm, another of fresh (hot!) asphalt, and the third sample of 325 cc vacuumed from the road surface all tested at below detection limits for arsenic, cadmium, chromium, lead, mercury, selenium and silver.

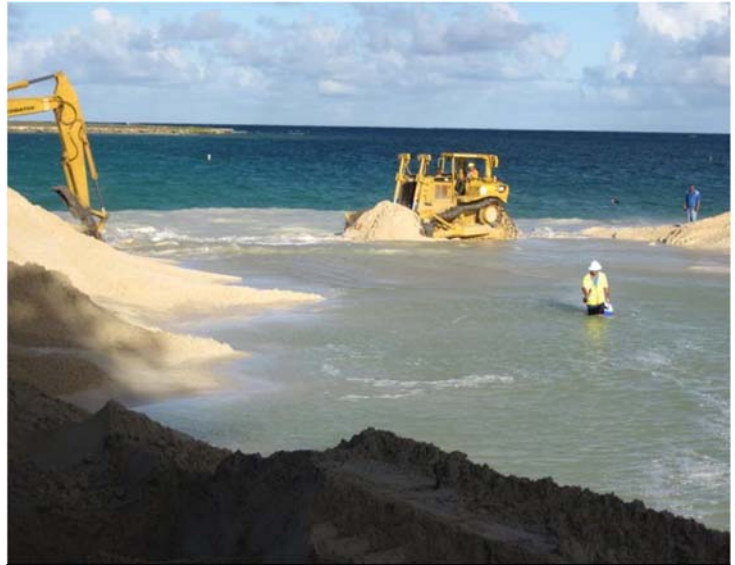
**Figure 28** The City uses heavy equipment to open the stream mouth about nine times per year.

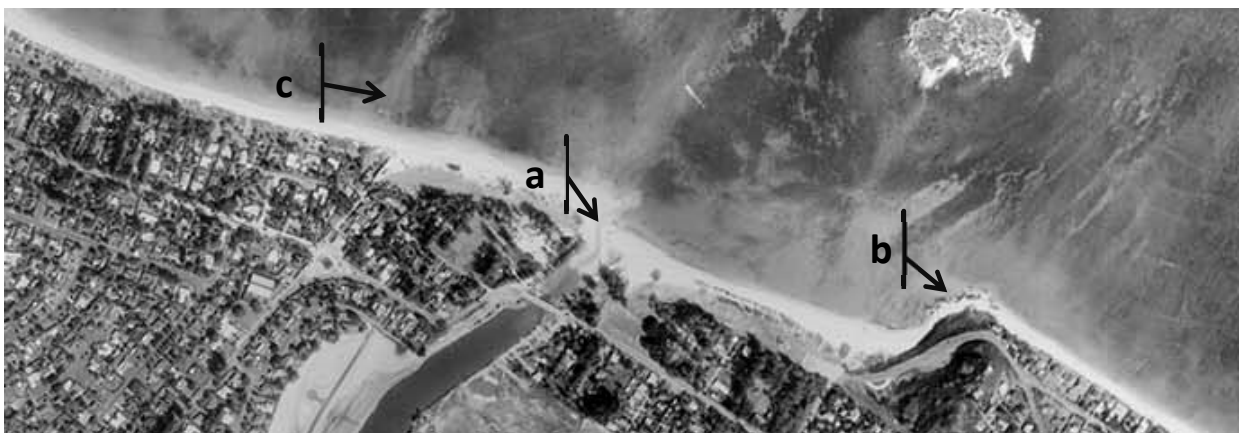
**Figure 29** 1963 aerial (USGS EKM-2CC-246) dated 1-14-63 prior to construction of Kawainui Levee. Note stream flowing across sand beach (a), and wide sand beach continuous around Aala Point and into Lanikai (b). Location of historic stream mouth channel (~1850 nautical chart) can be seen ~1,000 feet to the west (c).

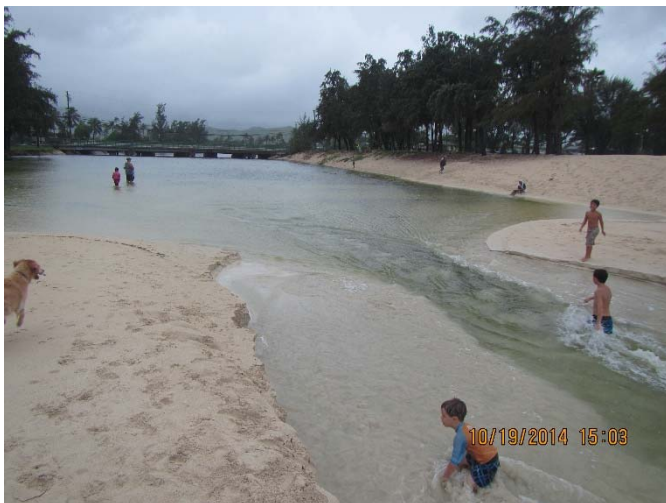
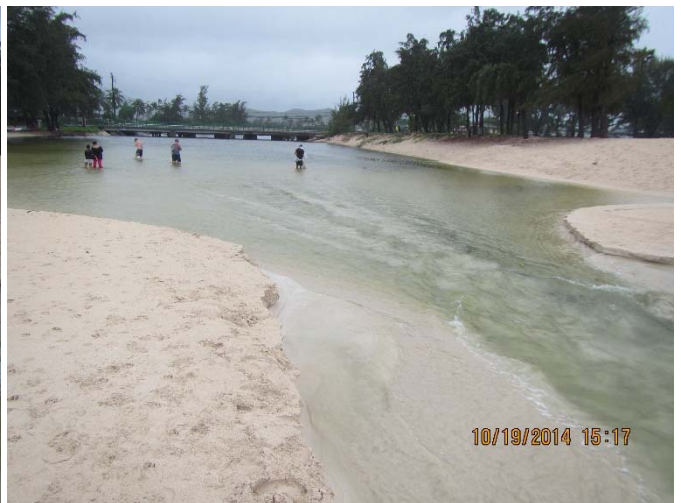
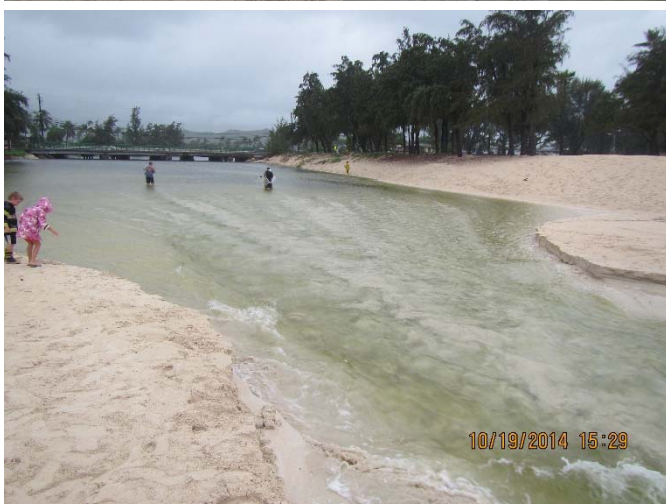
**Figure 30. October 2014 the City responded to a high water surface in the pond and an impending rainstorm to conduct an “emergency” opening of the stream mouth. Flow established in a 1-foot deep 15 foot wide channel completed at 16:15 developed into a 30-foot wide 3 foot deep channel in about an hour and fifteen minutes. Within minutes of the last photo the cameraman had to abandon his location as the bank was eroding from beneath his feet.**

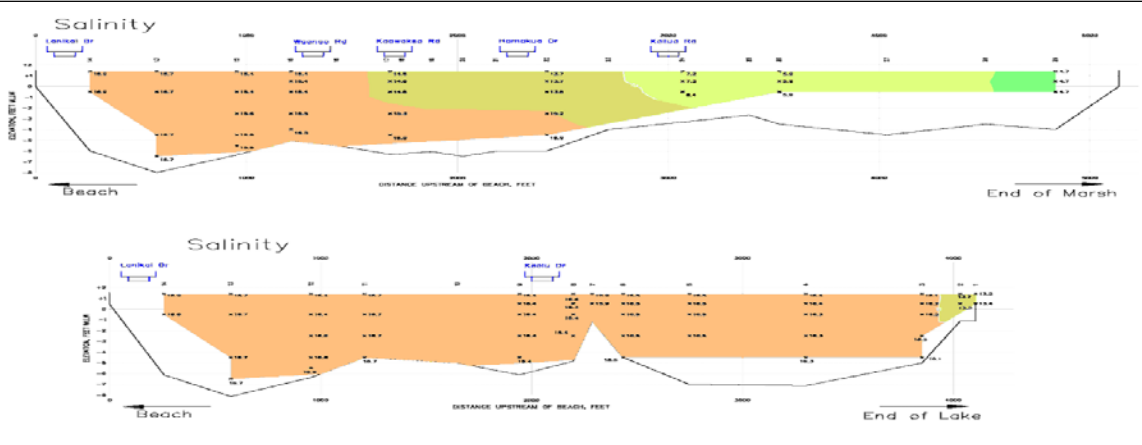
Before opening event, well mixed water profiles. Top: Kawainui Stream Bottom: Kaelepulu

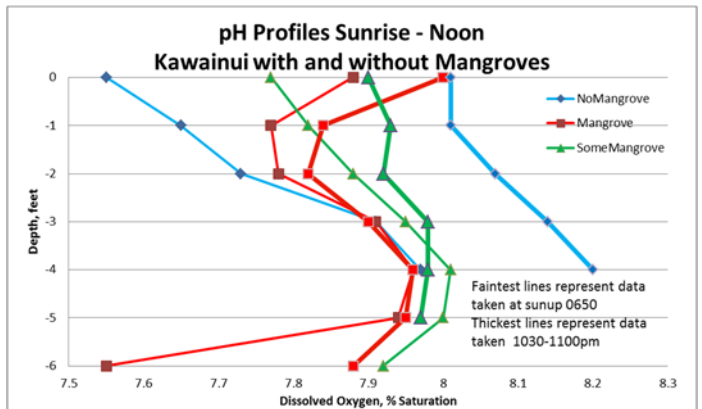
**Figure 36 Dissolved oxygen and pH profiles obtained in Kawainui channel at dawn and again at noon at three locations 1) in the midst of mature mangrove growth, 2) in an area where mangrove had been removed two-years prior, and 3) in an area with no mangroves. These graphics depict the adverse impact of mangroves upon dissolved oxygen and pH. Consistent with similar results obtained in Pearl Harbor, the ability of mangroves to adversely impact oxygen and pH water quality exists long after their removal, likely due to the presence of the massive root systems which are not typically removed when the trees are cut.**

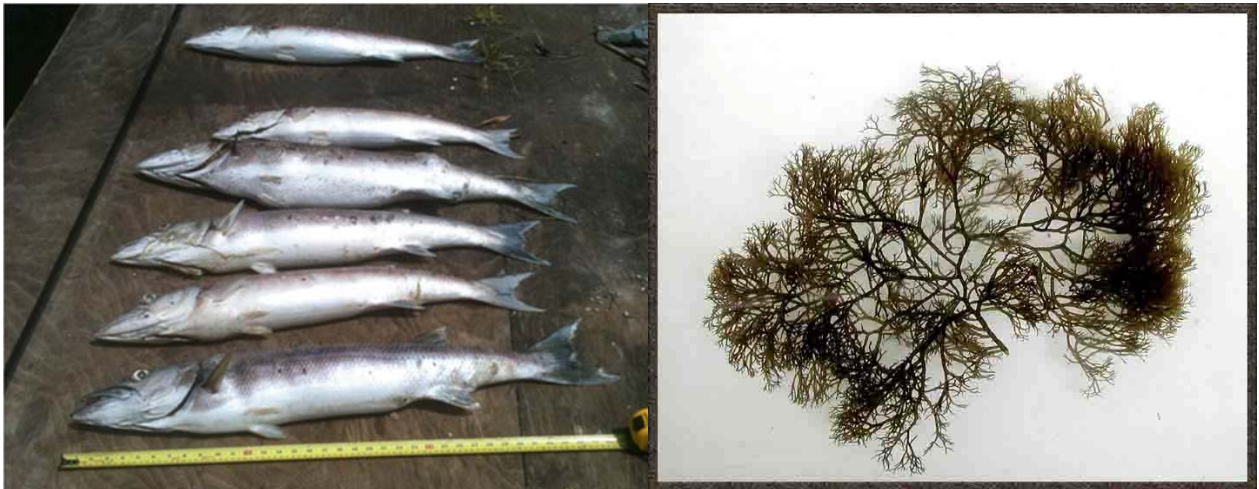
Figure 38 Large barracuda are common the in pond, these died due to an algae bloom. *Awa awa* schools feed almost exclusively on the macro *algae Gracilaria tikvahiae* as seen in the right hand photo.

The pond supports populations, in rough order of prevalence, of tilapia, gobies, milkfish, mullet, barracuda, papio, and lae. The papio (*Caranx ignobilis*) is a recent addition, first noted in the late summer of 2013 as small (4-6") juveniles, and presently (9/2016) as larger (12-20") sub-adults. The milkfish (*Awa*, *Chanos chanos*) occur in schools of 10's to a few hundred sub-adults (12-24") grazing on the macro-algae beds of *Gracilaria* (Figure 38) in shallow water. When the stream mouth is open, these *Awa awa* are targeted by throw-net fishermen near Lanikai Bridge. Barracuda are plentiful in the lake and are avidly sought by fishermen, most of whom release their catch. Sizes typically range from 24-39", but individuals approaching 72" have been reported (and personally seen by the author). The large barracuda in Figure 38 were all killed by a low oxygen event associated with overgrowth of macro-algae in the pond. The macro algae growth was likely stimulated by the inflow of sediments and associated nutrients from an upslope development grading project.

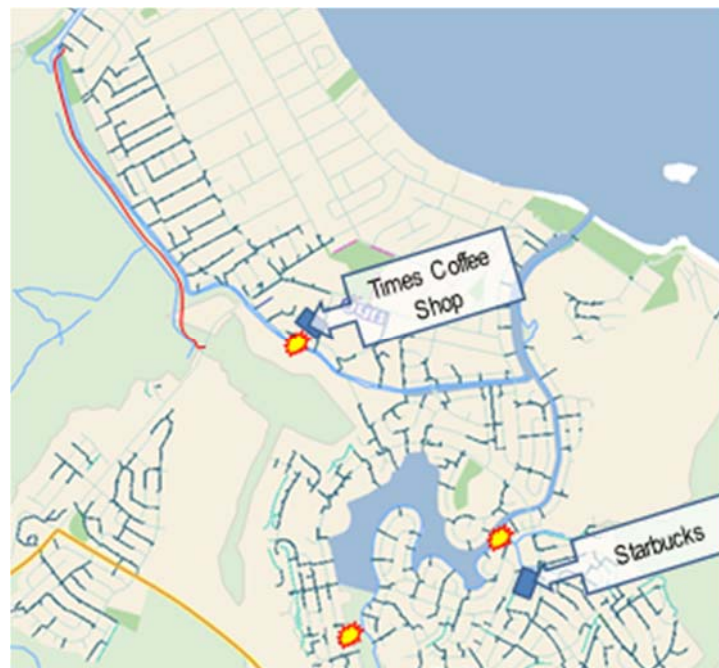
**Figure 40 Sample sites where caffeine was detected in surface waters, with overlay of local coffee houses.**

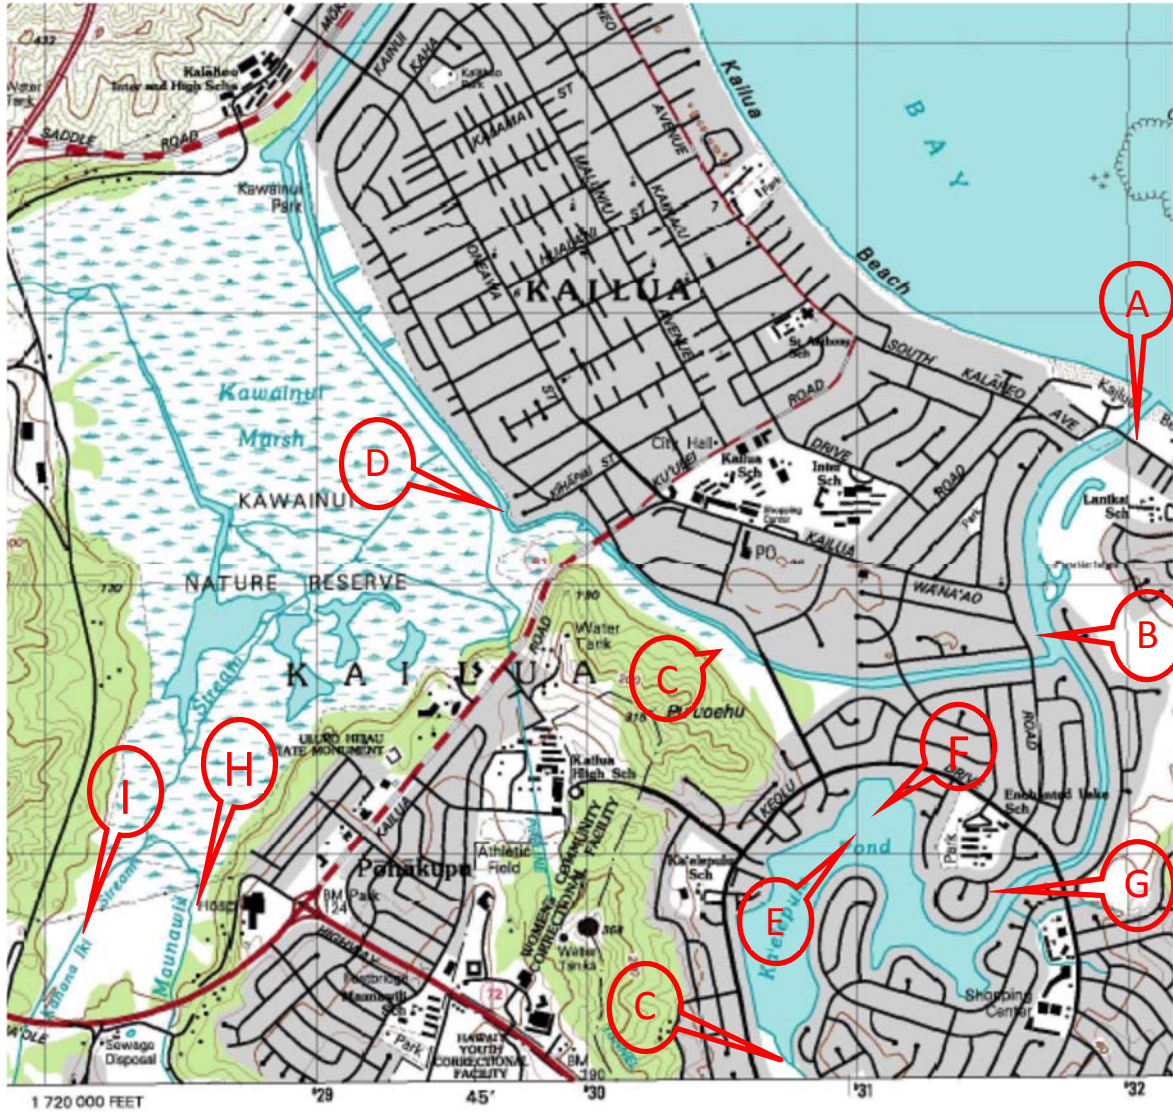
- A. Regular mulwai opening of Kaelepulu Stream at Kailua Beach
- B. Mangrove removal from estuary by ELRA and Kailua Canoe Club
- C. Wetland restoration for improved bird habitat, Kawainui, Hamakua, Kaelepulu .
- D. Kawainui Stream Flow Restoration from Kawainui Marsh
- E. State Total Maximum Daily Load study of Kaelepulu
- F. City Drainage Improvement Study and Implementation Report
- G. Dredging of blocked segment of Kaelepulu channel for improved circulation.
- H. Kawainui Bird Pond Construction
- I. State Stream Bank and Wetland Restoration
