Name of Project: **Establishing TMDLs to address wet weather flow impacts, pathogens, and NPDES program strategies in a priority urban watershed – Kaelepulu, Hawaii – Biological Survey**

This report addresses Objective 4 of the current project and that is to “Identify the occurrence, distribution, and life cycle status of existing biota in the inland brackish waters.” This was accomplished by conducting a biological assessment which is an evaluation of the condition of a waterbody using biological surveys and other direct measurements of the resident biota in surface waters. The survey was done between March 1- 8, 2012. The procedures followed were modified from Barbour, et al., (1999) entitled, Rapid Bioassessment Protocols (RPBs) for Use in Streams and Wadeable Rivers: Periphyton, Benthic Macroinvertebrates and Fish¹. The RPBs are essentially a synthesis of existing methods that have been employed by various other State Water Resource Agencies.

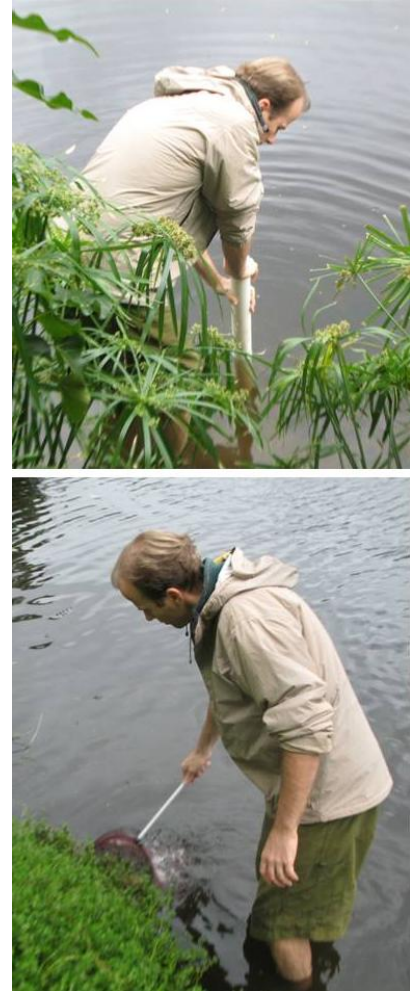
Figure 2. Dr. David Bybee using two collection methods for conducting the Macro-invertebrate survey.

The macro-invertebrate survey was conducted by Clyde Tamaru and Dr. David Bybee (Figure 2), assistant professor at Brigham Young University Hawaii. Dr. Bybee received his doctorate from the University of Hawaii at Manoa from the Department of Zoology and specialized in characterizing the reproduction and early life history of polychaete worms. Dr. Bybee identified the specimens obtained into the various invertebrate taxonomic groups that is used in the RPB assessment in the field. Two collection methods were used and included a core of the sediment using a 2.5 inch pvc pipe. Contents were sieved **threw** a pan equipped with a 500 μ m screen. The second utilized hand held dip nets that were taken at multiple samples (n= 5) along a 100 meter stretch of the sample site. Visual sightings were also used as a means of detecting the presence of macroinvertebrates throughout the sampling sites.

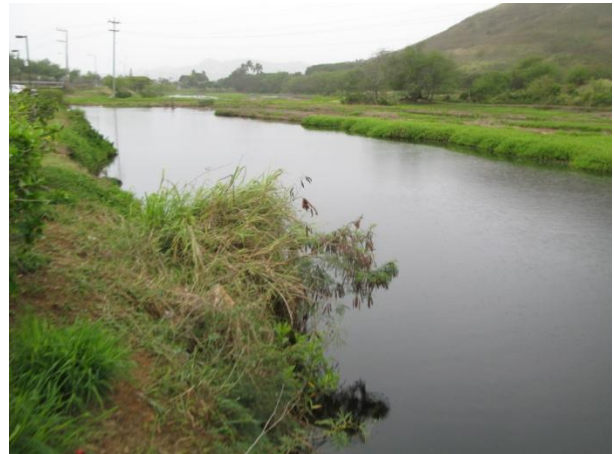
Figure 3. Sample Site #2 of the biological survey.

Channel alteration is a measure of large-scale changes in the shape of a stream channel and many streams in urban and agricultural areas have been straightened, deepened, or diverted into concrete channels, often for flood control or irrigation purposes. Such streams have far fewer natural habitats for fish, macroinvertebrates, and plants than do naturally meandering streams. Channel alteration is present when artificial embankments, and other forms of artificial bank stabilization or structures are present and when the stream is very straight for significant distances. A summary of this parameter for the various sample sites is provided in Table 11. A poor rating consists of banks shored with gabion or cement; over 80% of the stream reach channelized and disrupted. Although certain sample sites (e.g., #5, #6 and #7) clearly are not streams or even stream like they are being included in the assessment as the shorelines for each of the sampling sites clearly fit the criteria for the poor rating.

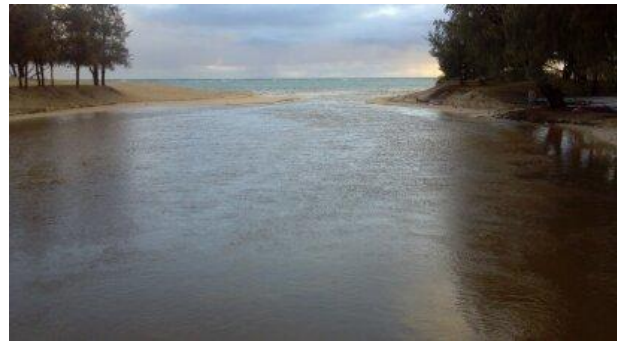
Sample of debris from Site #3 was quite devoid of anything living. There were a few very small diatom tests but they did not appear to be alive. There were a few flagellated and ciliated protozoans present but very few. This type of sample is usually characteristic of acidic waters containing decomposing vegetation. When left standing the water takes on a brown color (Figure 4) due to the build-up of tannins from the decomposition of leaf litter.

Figure 4. Water downstream of Site #3 emptying into Kailua Bay .

Since the area of the sampling was recently flushed with rain runoff it is suspected that the brown color would be flushed out leaving only sand and vegetative debris.

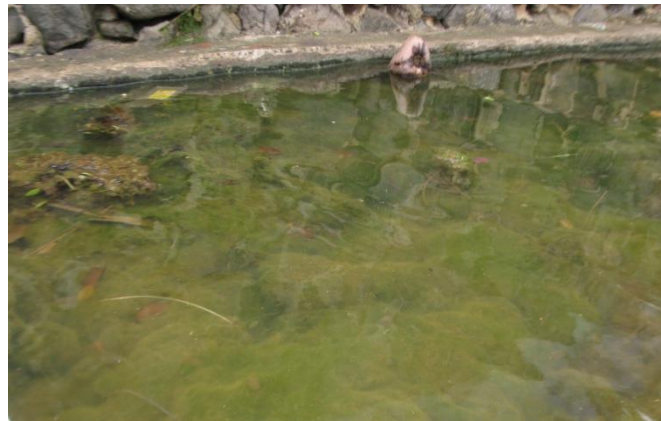
At Sample Site #6 a green filamentous algae was found covering 100% of the *G. tikvahiae* that was present. The green algae was keyed out to *Cladophora sericea*. This species is a branching green filamentous alga found on most reefs in Hawai‘i⁴. While this species is considered to be a native species it is also classified as invasive as it can spread and overgrow areas under the right conditions. *C. sericea* has demonstrated invasive characteristics in Hawai‘i, unlike the intertidal *C. vagabunda*. Approximately 10 years ago the alga became exceedingly abundant on leeward reefs in Maui and large blooms now occur seasonally. During the blooms, large masses of the alga drift in the water column, snagging on coral and rock outcroppings and smothering out the organisms beneath.

Figure 5. Photograph of *C. sericea* completely covering *G. tikvahiae* at Sample Site #6.

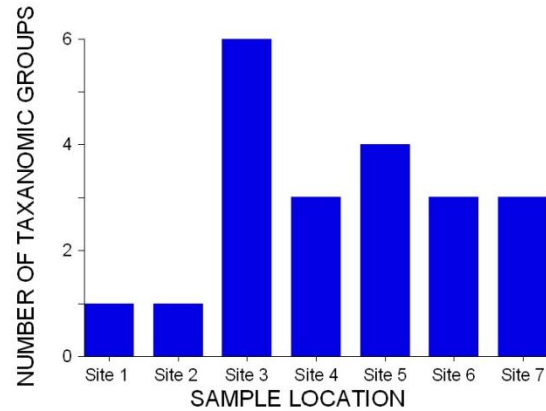
The number of distinct taxonomic groups represents the diversity of the macroinvertebrates within the survey and is a metric known as Taxa richness. This metric usually consists of species level identifications but can also be evaluated as designated groupings of taxa, often as higher taxonomic groups (i.e., genera, families, orders, class etc.) just as has been done for the assessment of macroinvertebrate assemblages in the current survey. The expected response to increasing perturbation varies depending on the metric but increasing diversity correlates with increasing health of the assemblage and suggests that niche space, habitat, and food source are

adequate to support survival and propagation of many species. The predicted response of the number of taxa to a perturbation is for the Taxa richness metric to decrease. This can be illustrated graphically by displaying the number of taxa per sample location (Figure 6). Sample Site #3 was found to possess the highest taxa richness metric of all the sample sites. Sites #1 and #2 were observed to have the lowest values for the same metric. Both of these sites also possess the lowest dissolved oxygen levels as well as salinity clearly marking them as being impacted habitat. The lowered value in taxa richness at these two sites is consistent with a suitable metric that responds as predicted.

Figure 6. Variation in the number of taxonomic groups of macroinvertebrates at various sampling sites obtained during the current biological survey.
